Pre-shipment Inspection Report		Conclusion  
	Client (abbr.):	MJH International B.V.	PASSED
	Report Number:	Q55809EY	
	Report Date:	16 May 2020	Page 1 / 50

Supplier:	Guangzhou Bofeite Safety Protective Supplies Co., Ltd	
Factory:	Guangzhou Bofeite Safety Protective Supplies Co., Ltd	
Product Name:	Disposable mask KN95	
P.O. No.:	FZXQ2002	
Item No.:	HT9510	
Order Quantity:	5.1.1c	
Sample Size:		
Man-day Quantity:	1 Man-day(s)	
Destination:	The Netherlands	
Inspection Date:	16 May 2020	
Re-Inspection:	<input type="checkbox"/> Yes <input checked="" type="checkbox"/> No	
Reference Sample:	<input checked="" type="checkbox"/> No Reference Sample On-site <input type="checkbox"/> Product Specification <input type="checkbox"/> P.O. <input type="checkbox"/> Packaging Spec.	
Available Quantity:	5.1.1c (Production Completion rate: 80% Packing Completion rate: 80%)	
Inspection Location:	Guangzhou, Guangdong Province GPS Map (Longitude: 113.674431, Latitude: 23.173534)

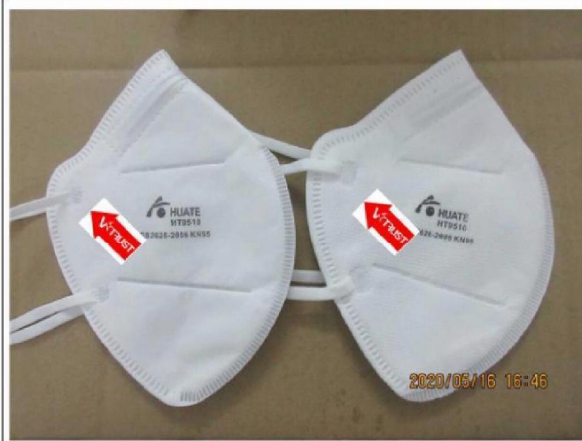
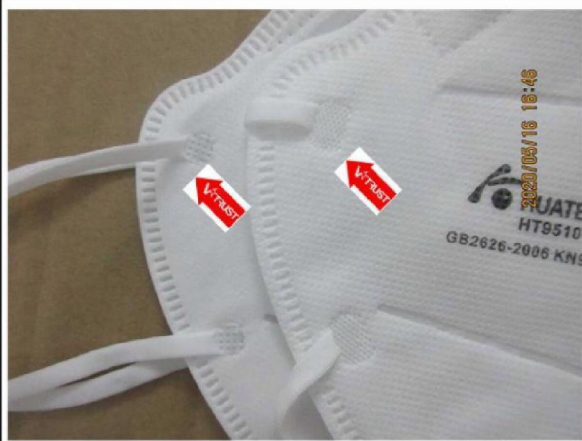
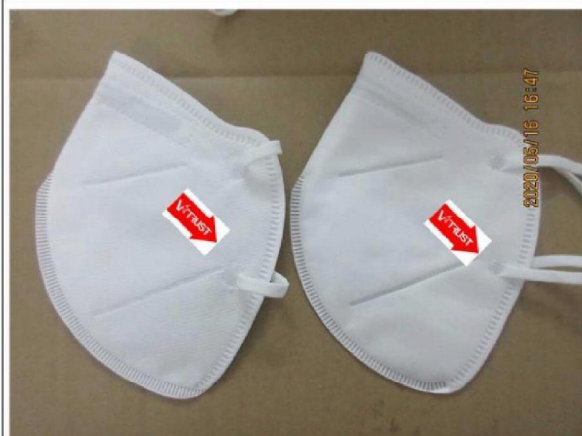
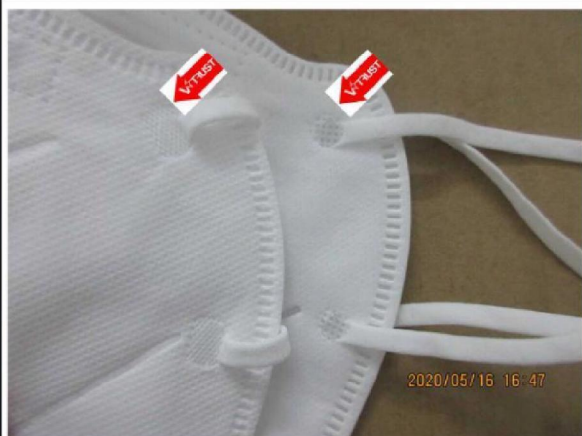
4.	Two lots shape of welding point were found on site. Lot A was 90% and the lot B was 10%. Please refer to below photos for detail.	
5.	All selected gift box was found with bulgy mark(0.5-1cm). Please refer to below photos for detail.

↑ 1 - Remark 4, Two lots shape of welding point were found on site. Lot A was 90%(left) and the lot B was 10%(right).

↑ 2 - Remark 4, Two lots shape of welding point were found on site. Lot A was 90%(left) and the lot B was 10%(right).

↑ 3 - Remark 4, Two lots shape of welding point were found on site. Lot A was 90%(right) and the lot B was 10%(left).

↑ 4 - Remark 4, Two lots shape of welding point were found on site. Lot A was 90%(right) and the lot B was 10%(left).

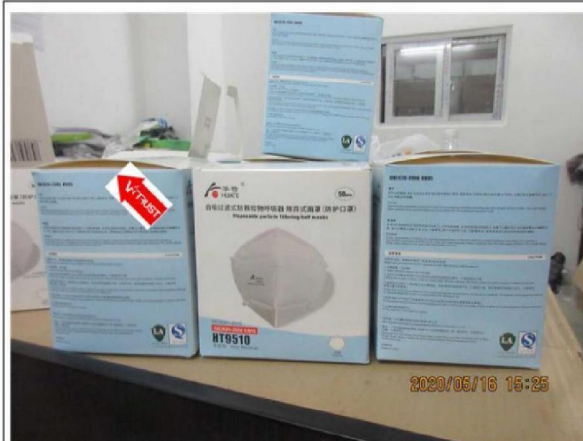
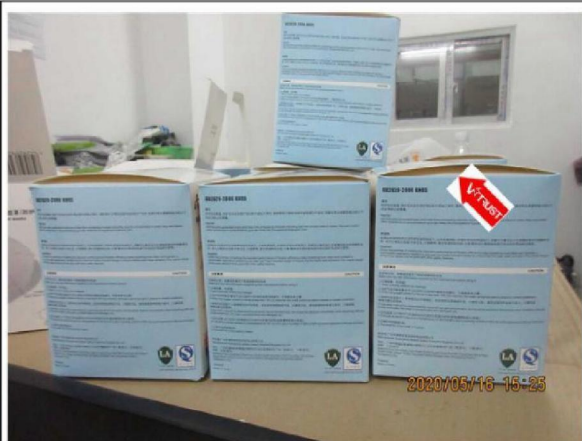
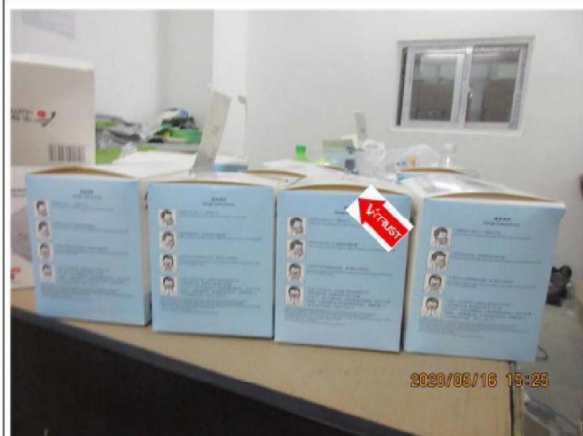
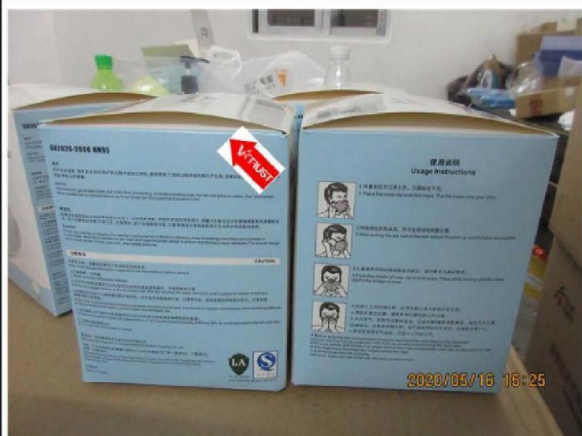
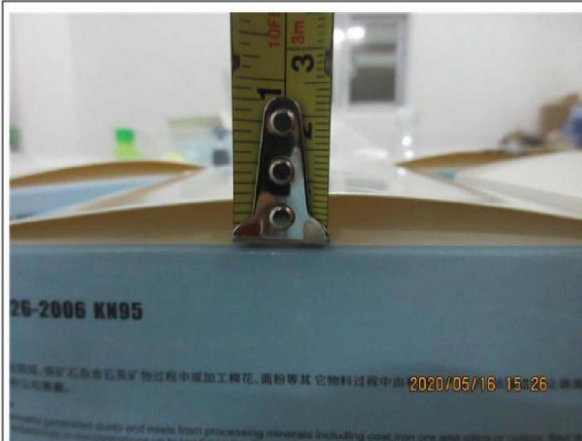
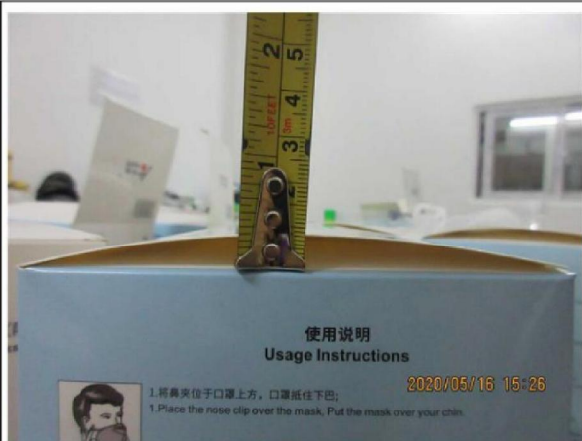
↑ 5 - Remark 5, All selected gift box was found with bulgy mark(0.5-1cm).

↑ 6 - Remark 5, All selected gift box was found with bulgy mark(0.5-1cm).

↑ 7 - Remark 5, All selected gift box was found with bulgy mark(0.5-1cm).

↑ 8 - Remark 5, All selected gift box was found with bulgy mark(0.5-1cm).

↑ 9 - Remark 5, All selected gift box was found with bulgy mark(0.5-1cm).

↑ 10 - Remark 5, All selected gift box was found with bulgy mark(0.5-1cm).

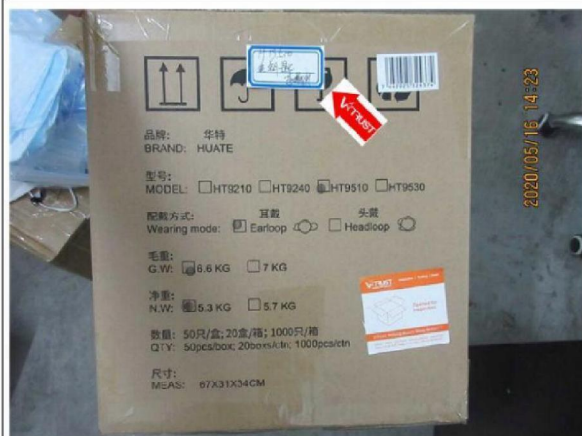
6.	A label was stuck on the side mark. The factory claimed they would rip down before shipment. Please refer to below photos for detail.	
7.	The executed standard was GB 2626-2006 marked on gift box and certificate quality.

↑ 11 - Remark 6, A label was stuck on the side mark.

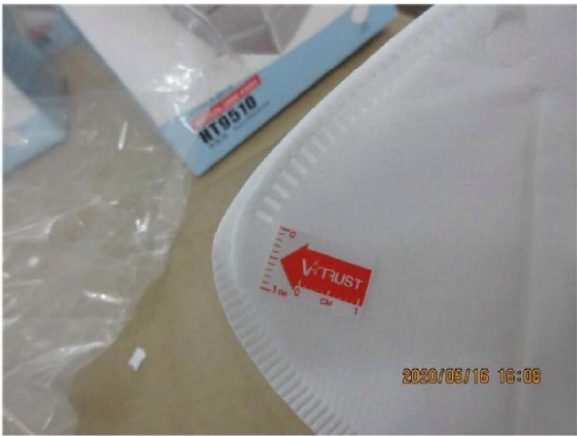
<p>↑ 19 - Uneven edge - minor</p>	<p>Nil</p>
