| | <b>During Production Inspection Report</b> | | Conclusion |
| | Client (abbr.): | MJH International B.V. | <b>PASSED</b> |

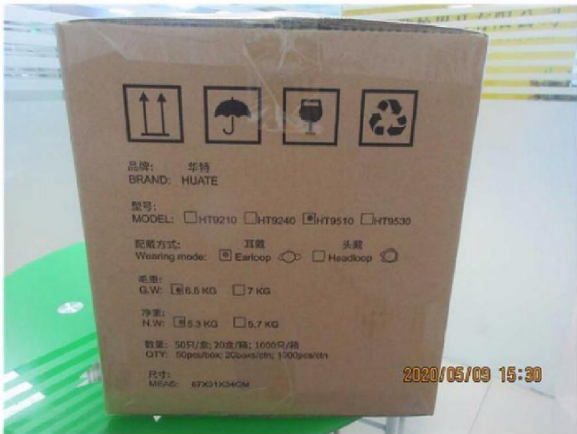
| <p>↑ 1 - Remark 2, No barcode was found on carton box, but it was request by client.</p> | <p>↑ 2 - Remark 2, No barcode was found on carton box, but it was request by client.</p> |

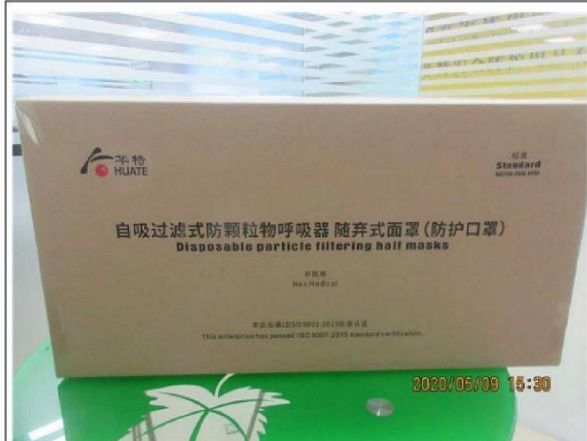
↑ 3 - Remark 2, No barcode was found on carton box, but it was request by client.

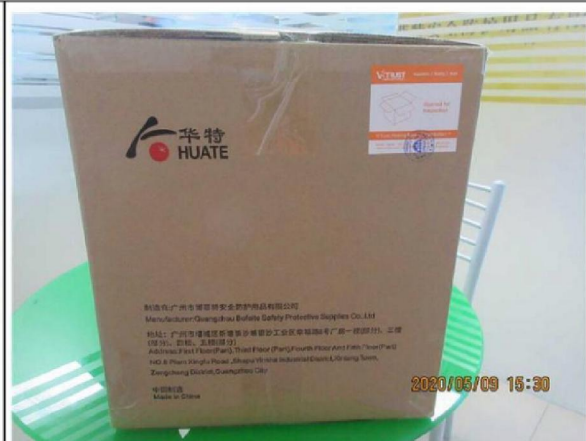
↑ 4 - Remark 2, No barcode was found on carton box, but it was request by client.

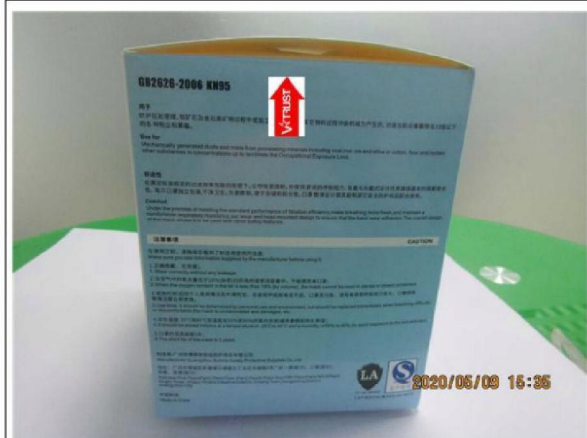
↑ 5 - Remark 3, Bulgy mark was found on the gift box in all selected samples.

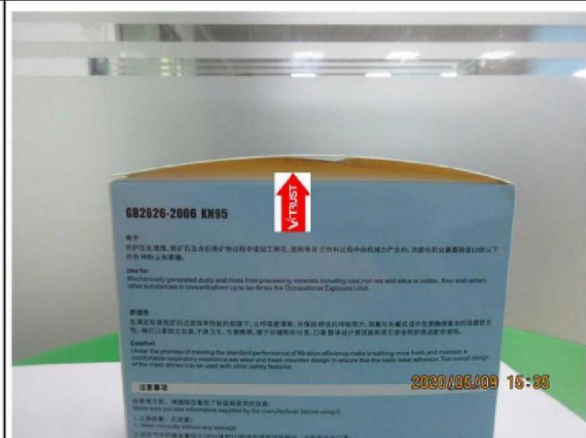
↑ 6 - Remark 3, Bulgy mark was found on the gift box in all selected samples.

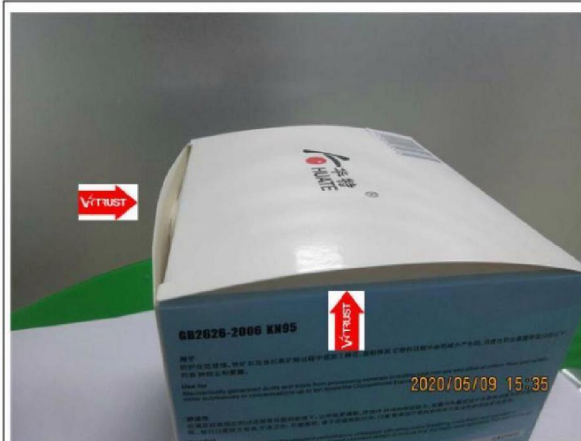
↑ 7 - Remark 3, Bulgy mark was found on the gift box in all selected samples.

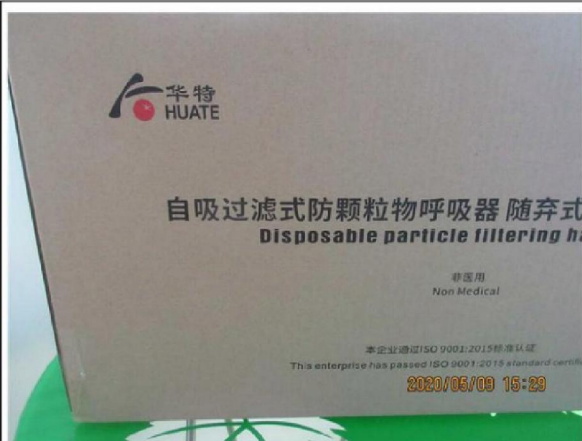
↑ 8 - Remark 4, Chinese words was found on the gift box and carton box in all selected samples.

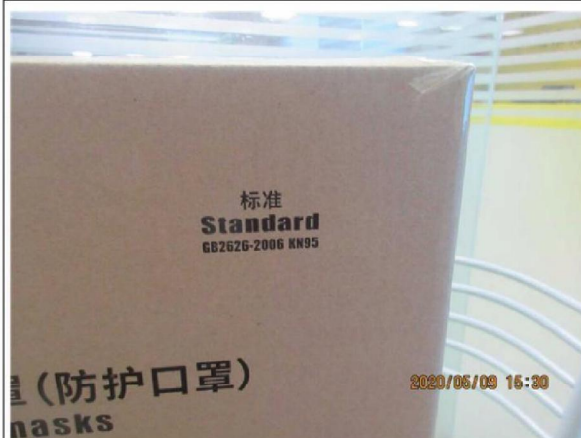
↑ 9 - Remark 4, Chinese words was found on the gift box and carton box in all selected samples.

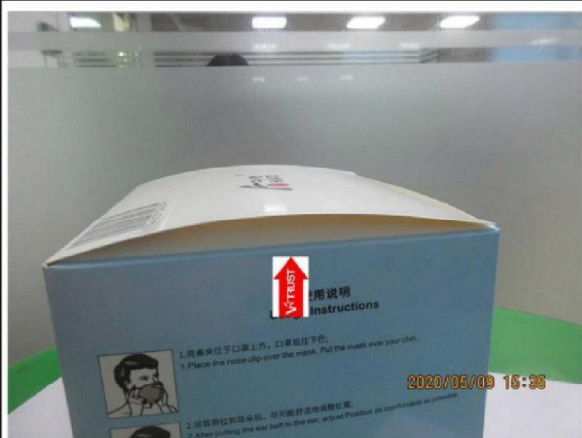
↑ 10 - Remark 4, Bulgy mark was found on the gift box in all selected samples.

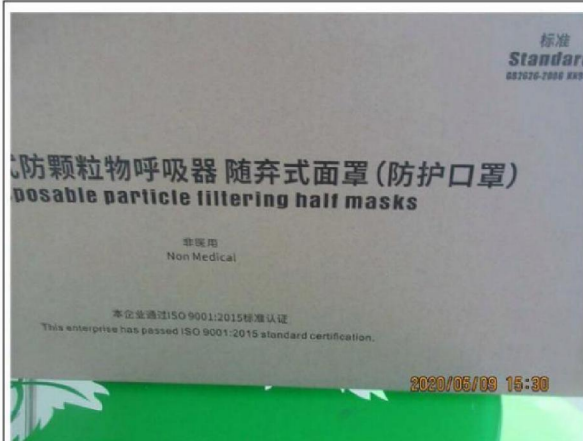
↑ 11 - Remark 4, Chinese words was found on the gift box and carton box in all selected samples.

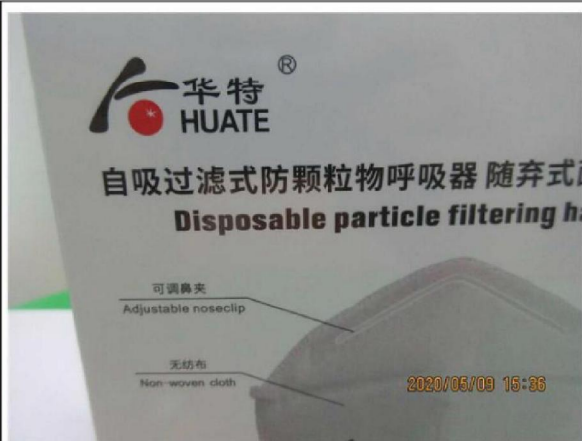
↑ 12 - Remark 4, Chinese words was found on the gift box and carton box in all selected samples.

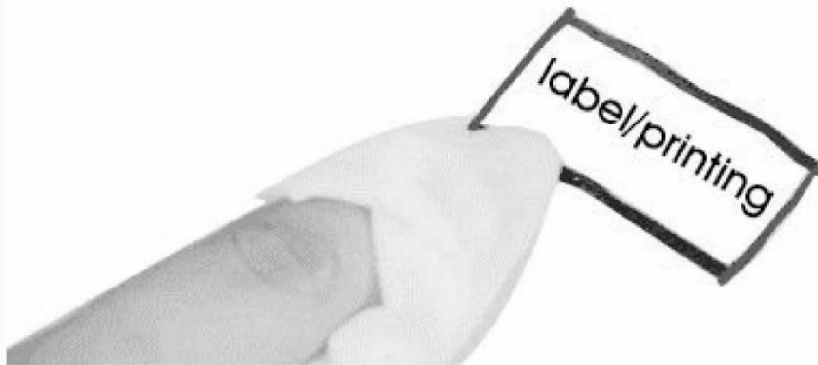
**Carton Drop Test**

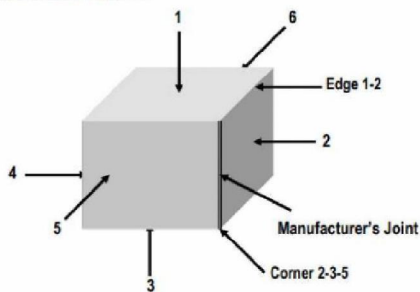
| Sequence # | Orientation | Specific face, edge or corner |
