**FINAL INSPECTION REPORT**

Vendor : Refiand Industrial (HK) Company Ltd		Maker Name match to PO: <input checked="" type="checkbox"/> Y / <input type="checkbox"/> N	
Maker Name: Huizhou Lexusiance Technology Co., Ltd		Maker Address match to PO: <input checked="" type="checkbox"/> Y / <input type="checkbox"/> N	
Item Description: FFP2 masks EN149:2001, A1:2009			
PO No.: MB579024 MB578962 R4V10 MB579049 MB579080	Indent No.: TBA P-TRDNL02000002	Art. no.: REFNN95	Order Qty: 5.1.1c <input checked="" type="checkbox"/> Pieces <input type="checkbox"/> Sets <input type="checkbox"/> Ctns

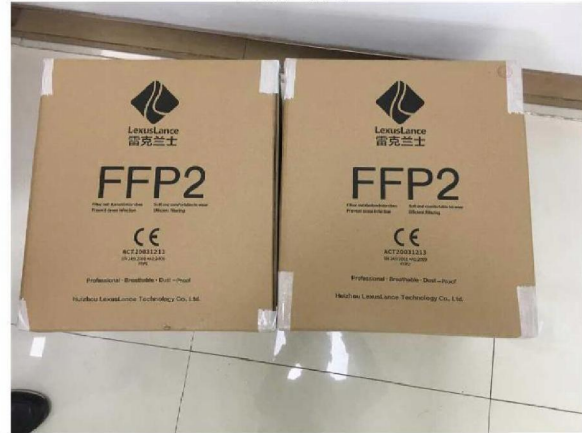
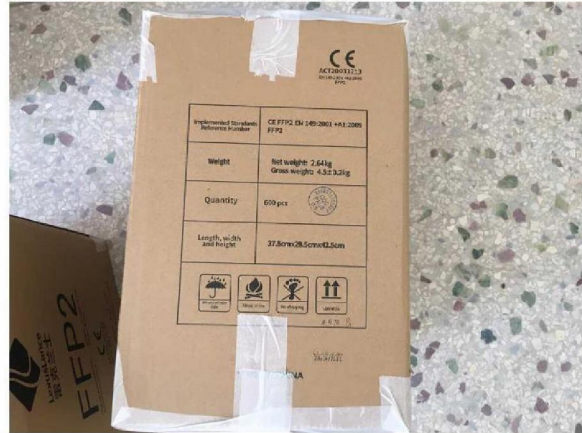
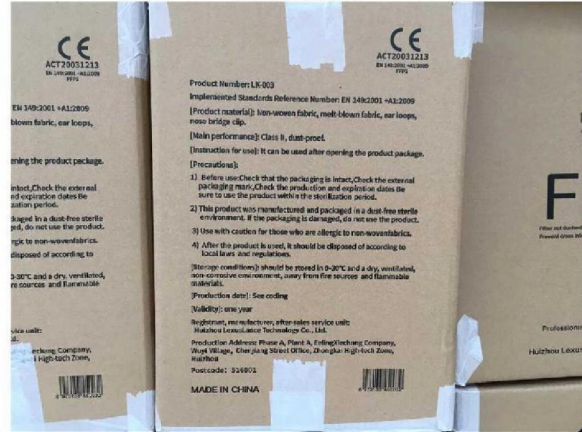
Master carton

-5pcs per each poly bag with certificate of approval; -10 poly bag per each color box with certificate of approval; -12 color box per each master carton with certificate of approval; - total 600pcs for each carton.	
Master Carton	<input checked="" type="checkbox"/> Made in China / <input type="checkbox"/> Resy Logo / <input type="checkbox"/> Carton Label / <input type="checkbox"/> Metal staples / <input checked="" type="checkbox"/> Barcode label Taped method : <input type="checkbox"/> I / <input checked="" type="checkbox"/> H / <input type="checkbox"/> 王; With plastic Tie: <input type="checkbox"/> Yes / <input checked="" type="checkbox"/> No / Cardboard on: <input type="checkbox"/> Top; <input type="checkbox"/> Bottom
Gift Box	<input checked="" type="checkbox"/> Made in China / <input type="checkbox"/> Recycle Mark / <input type="checkbox"/> Green Dot <input type="checkbox"/> Logo / <input checked="" type="checkbox"/> Barcode / <input checked="" type="checkbox"/> Ref. No.: LK-003-A004 <input type="checkbox"/> Closed by tape; <input type="checkbox"/> Top / <input type="checkbox"/> Bottom; / <input checked="" type="checkbox"/> Others : CE mark

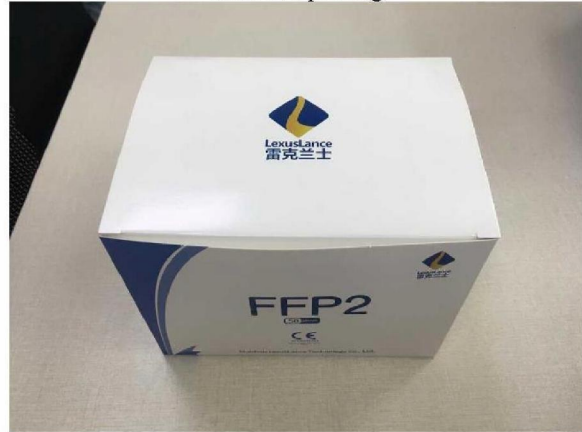
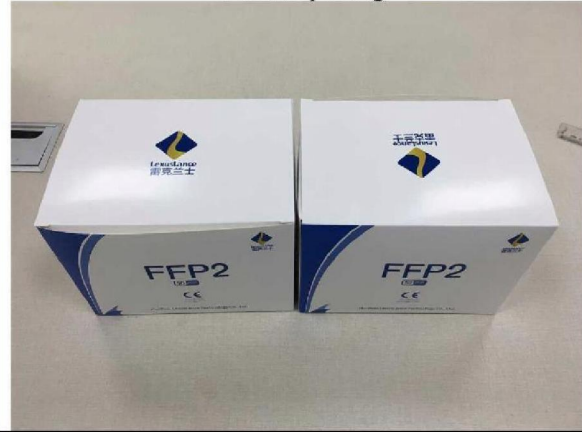
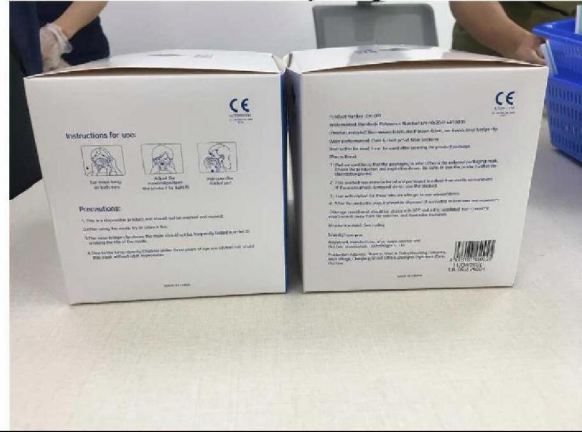
Inner box printing

Polybag / Bubble Bag	<input type="checkbox"/> Recycle Mark / <input type="checkbox"/> Green Dot / <input checked="" type="checkbox"/> Barcode / <input checked="" type="checkbox"/> Hole <input type="checkbox"/> Warning Text / <input checked="" type="checkbox"/> Ref. No.: LK-003-A004 <input type="checkbox"/> Closed by tape / <input checked="" type="checkbox"/> Closed by self-sticking / <input checked="" type="checkbox"/> Closed by heat seal / <input type="checkbox"/> Label  <b>Lexuslance LK-003, FFP2, CE, EN149: 2001+A1 :2009</b> <b>Barcode: 6973133450018, "Made in China"</b> <b>Product Lot: LK-003-A004</b> <b>Production date: 23/04/2020</b> <b>Validity date: 1 years</b>
Main Unit	<b>Lexuslance LK-003, FFP2, EN149: 2001+A1: 2009, CE</b>

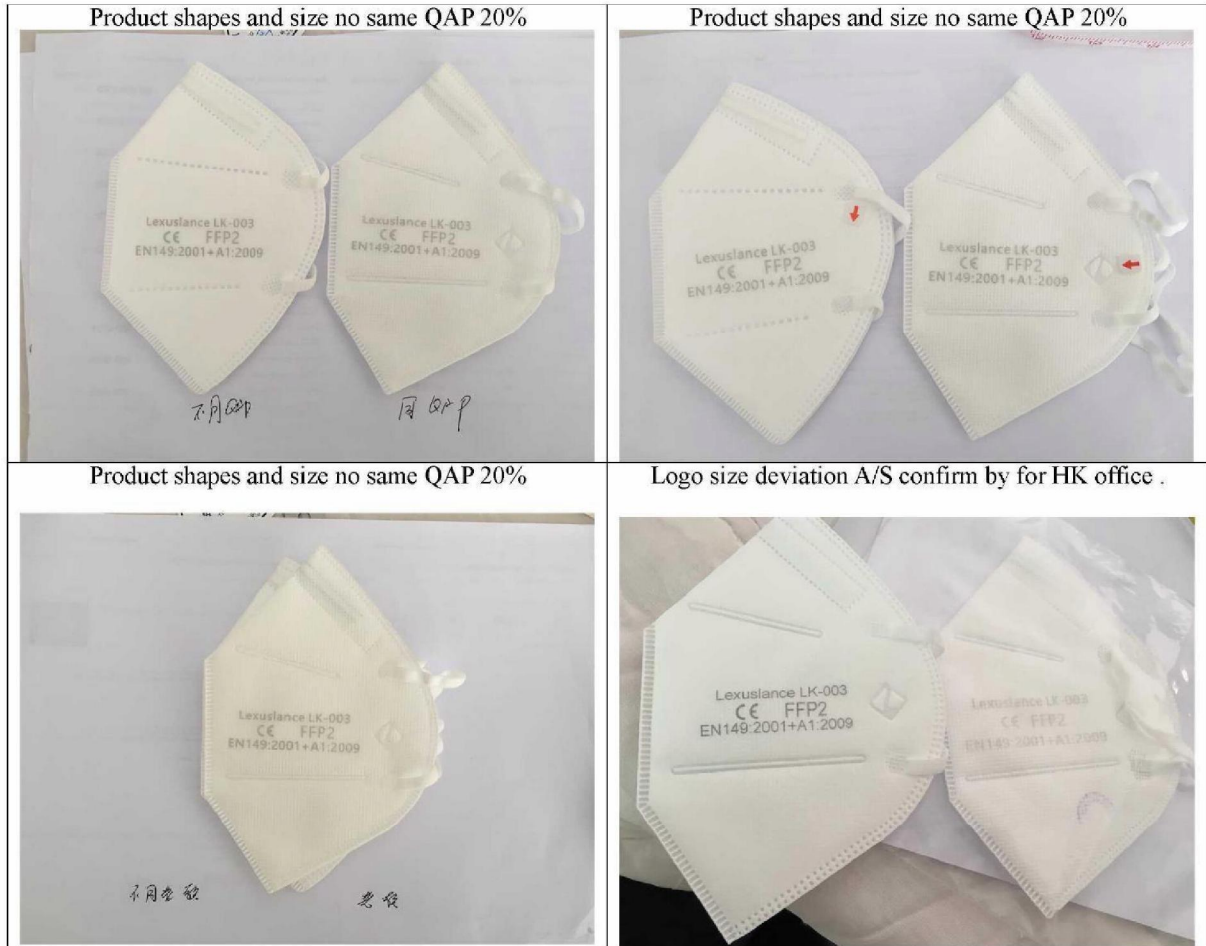
**Remark:**

- Masks product inspection with normal inspection S-3 sampling.
- There are two kinds of hot pressure around the nose clip (which have been distinguished from packing)
- There are two kinds of edge indentation.
- Nose clip visible, because assembly position is different.
- A small part of the product logo is lighter in color.
- There are two kinds of Nose clip metal strip length(8.5cm,9.0cm)
- Product shapes and size no same QAP 20%, confirm by HK office Jack Ho
- Logo size deviation with A/S,confirm by HK office Jack Ho.

<p>There are two kinds of hot pressure around the nose clip</p>	<p>There are two kinds of edge indentation</p>
<p>Nose clip visible, because assembly position is different.</p>	<p>A small part of the product logo is lighter in color.</p>
