FINAL INSPECTION REPORT

Date: 03 (D) 05 (M) 2020 (Y)	Time : In 11:00 / Out 17:30	Submission: ① <input checked="" type="checkbox"/> / ② <input type="checkbox"/> / ③ <input type="checkbox"/> / ④ <input type="checkbox"/>	Report no.: ADM 0057160
--	---------------------------------------	--	--------------------------------

Item Description: FFP2 MASK EN149:2001 +A1:2009			
PO No.: MB 579082	Indent No. : P-TRDNL02000005	Art. no.: HMSN95	Order Qty: 5.1.1c <input checked="" type="checkbox"/> Pieces <input type="checkbox"/> Sets <input type="checkbox"/> Ctns

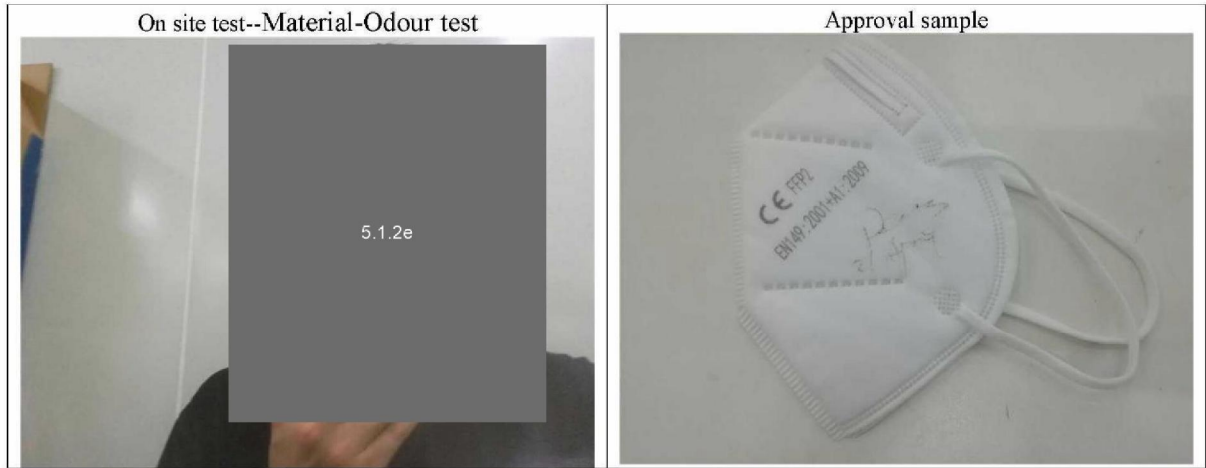
<p>On site test--Material layer quantity check</p>  	<p>On site test--Laser light through test</p>  
<p>On site test--Water leakage test</p>  	<p>On site test--Lot code check(20200406)</p>   <p>Manual for Protective Mask</p> <p>[Product Name] Foldable Disposable Mask [Packaging Quantity] 30Pieces/Box. [Size] 15.5cm x 10.5cm [Material] Five layers non-woven face mask.Inner and outer layers are polypropylene spunbond.Middle let 1 layer staticfree foam and 2-polypropylene meltblown. The also contains a adjustable nose piece and a elastic ear loop. [Storage and Transportation] Masks should be stored in a well ventilated room with a relative humidity not exceeding 80% and a temperature of -5°C to 40°C. Cautions to be taken in transportation to avoid direct sunshine, rain and harmful substances. [Manufacture] Jiangsu Nanfang Medical CO.,LTD. LOT 20200406 CE 2023-04 No.1 Guoxiang Rd., Wujin Economic Development Zone, Changzhou, Jiangsu, P.R.C BFE >95% MADE IN CHINA</p>

<p>On site test--Color fastness for rubbing</p>  	<p>On site test--Material thickness</p>

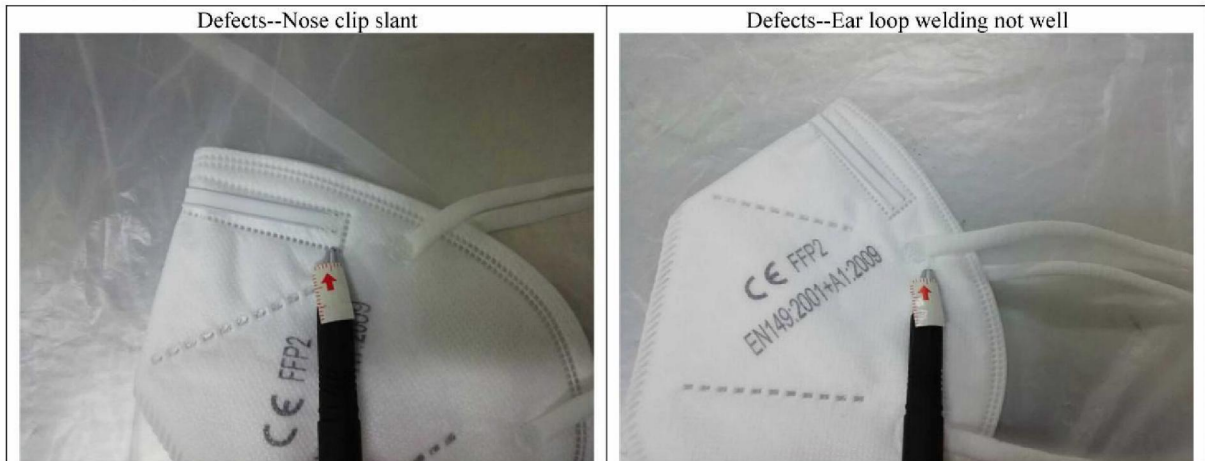
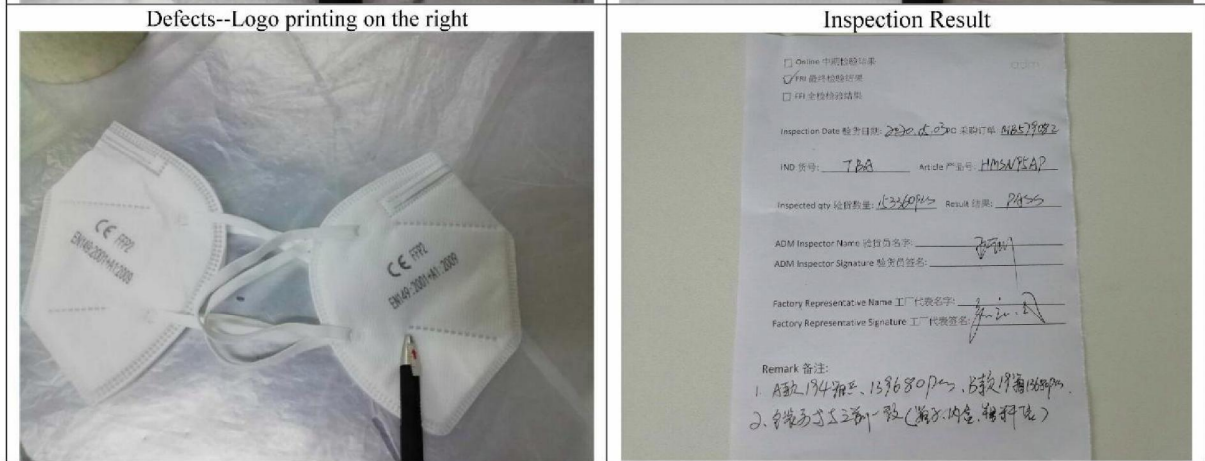
Minor defects:

A. Workmanship and functional inspection	Inspection Standard: ANSI / ASQ Z1.4 – 2008; Single sampling plans for normal inspection level: <input type="checkbox"/> III / <input checked="" type="checkbox"/> II / <input type="checkbox"/> I				
	Acceptable Quality Level (AQL): Critical Safety: <u>Not allowed</u> ; Critical functional: <u>0.4</u> ; Major + Critical functional: <u>1.0</u> ; Minor: <u>2.5</u> ;				
No.:	Defects Description	CRS	CRF	Major	Minor
1	Dirty mark		1		
2	Ear loop come off		2		
3	Welding edge broken			1	
4	Poor printing			1	
5	Nose clip welding not well			4	
6	Ear loop welding not well				1
7	Nose clip slant				7
8	Logo printing on the right				8
Total Defects Found		0	3	6	16
Maximum Allowed		0	7	14	21
