Pre-shipment Inspection Report		Conclusion  
	Client (abbr.):	MJH International B.V.	PASSED
	Report Number:	Q55809EY	
	Report Date:	16 May 2020	Page 1 / 50

Supplier:	Guangzhou Bofeite Safety Protective Supplies Co., Ltd	
Factory:	Guangzhou Bofeite Safety Protective Supplies Co., Ltd	
Product Name:	Disposable mask KN95	
P.O. No.:	FZXQ2002	
Item No.:	HT9510	
Order Quantity:	5.1.1c	
Sample Size:		
Man-day Quantity:	1 Man-day(s)	
Destination:	The Netherlands	
Inspection Date:	16 May 2020	
Re-Inspection:	<input type="checkbox"/> Yes <input checked="" type="checkbox"/> No	
Reference Sample:	<input checked="" type="checkbox"/> No Reference Sample On-site <input type="checkbox"/> Product Specification <input type="checkbox"/> P.O. <input type="checkbox"/> Packaging Spec.	
Available Quantity:	5.1.1c (Production Completion rate: 80% Packing Completion rate: 80%)	
Inspection Location:	Guangzhou, Guangdong Province GPS Map (Longitude: 113.674431, Latitude: 23.173534)

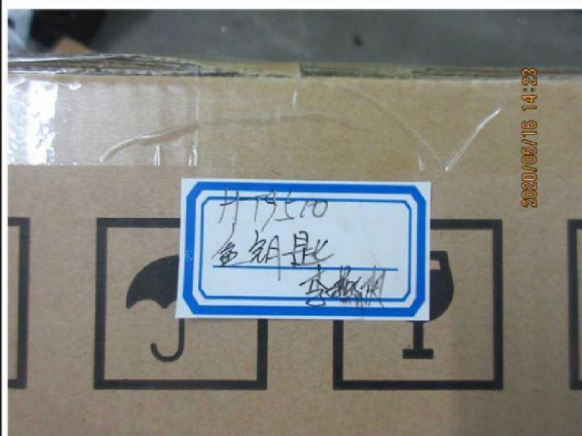
↑ 12 - Remark 6, A label was stuck on the side mark.

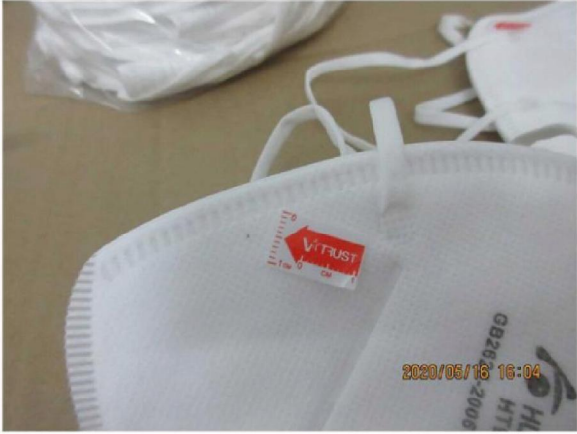
<p>↑ 17 - Dirt mark on surface - minor</p>

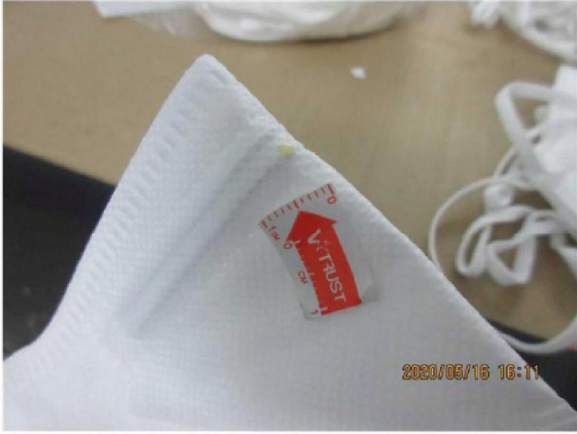
<p>↑ 18 - Dirt mark on surface - minor</p>

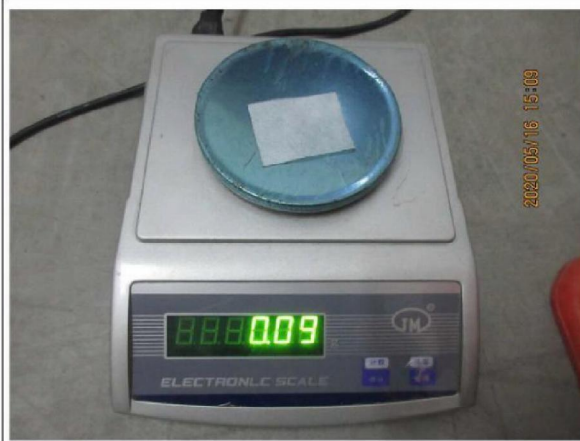
↑ 72 - Fabric Weight Check 45gsm

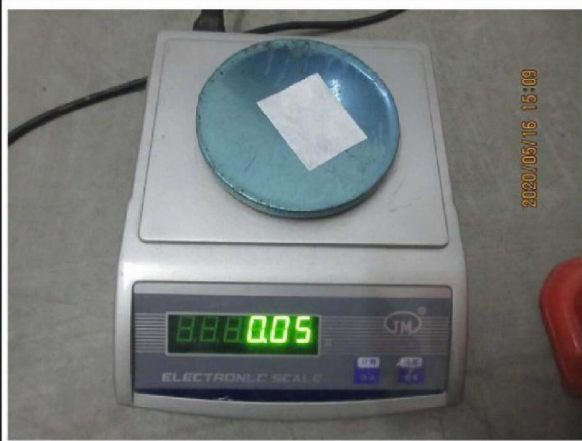
↑ 73 - Fabric Weight Check 25 gsm

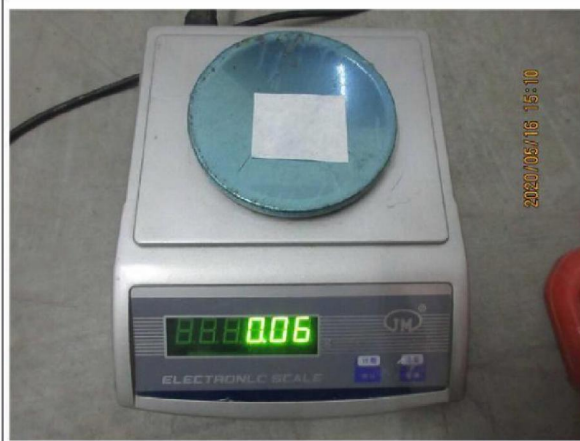
↑ 74 - Fabric Weight Check 30gsm

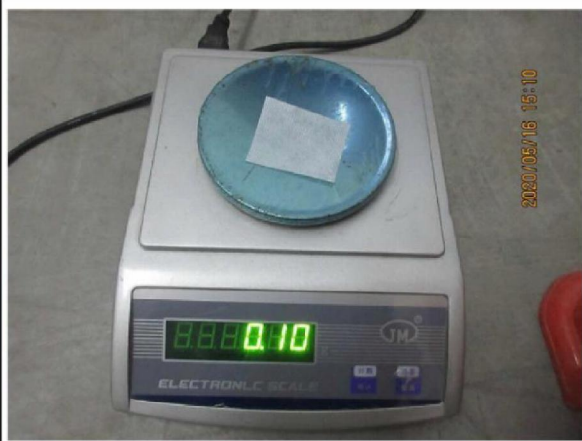
↑ 75 - Fabric Weight Check 50gsm

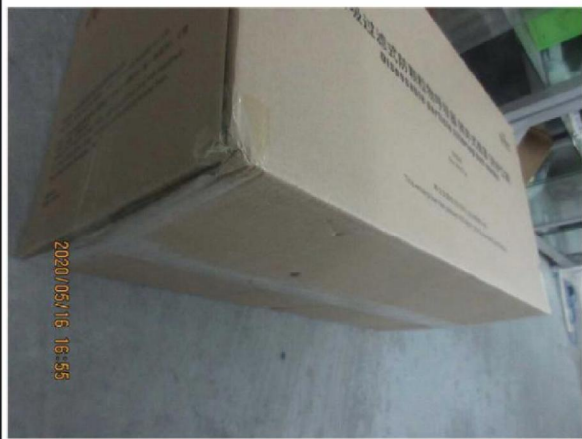
9.	Carton Drop Test - One corner, three edges, six sides, at height of - 30inch (9.5kg) - 24inch (9.5kg~18.6kg) - 18inch (18.6kg~27.7kg) - 12inch (27.7kg~45.3kg) - 8inch (45.3kg~68kg) on the cement floor. - No unit drop out, No any damage on unit.		Passed

↑ 81 - Carton Drop Test

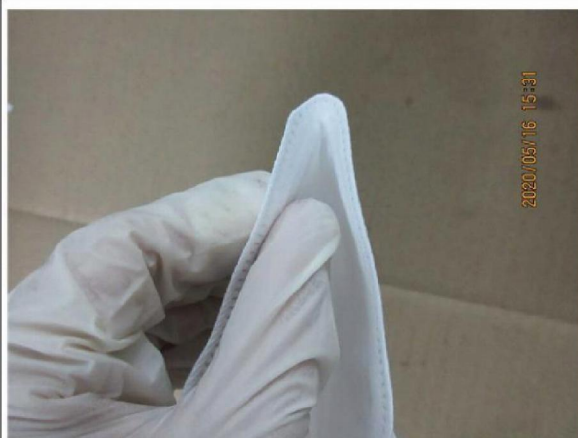
14.	Nose Clip Check - The mask should be fitted with a nose clip which is adjustable - No failure		Passed

↑ 89 - Nose Clip Check

↑ 90 - Nose Clip Check

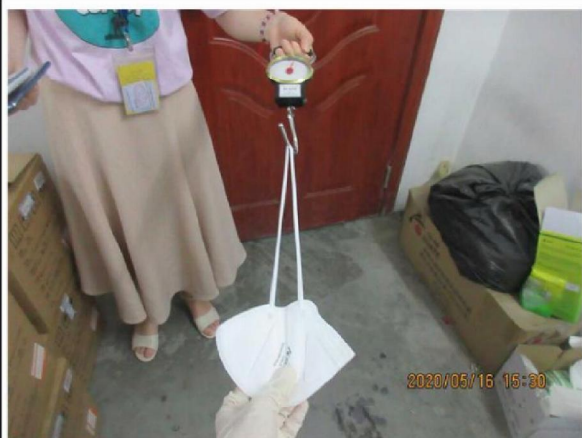
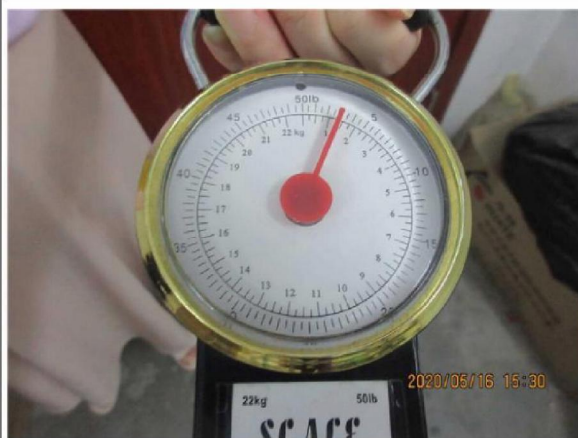
15.	<p>Mask Rope Check</p> <ul style="list-style-type: none"> - The mask rope is easy to adjust and should be with enough strength to fix the mask. Pull the mask rope with 10N force without breaking - No failure 	5.1.1c	Passed

↑ 91 - Mask Rope Check

↑ 92 - Mask Rope Check

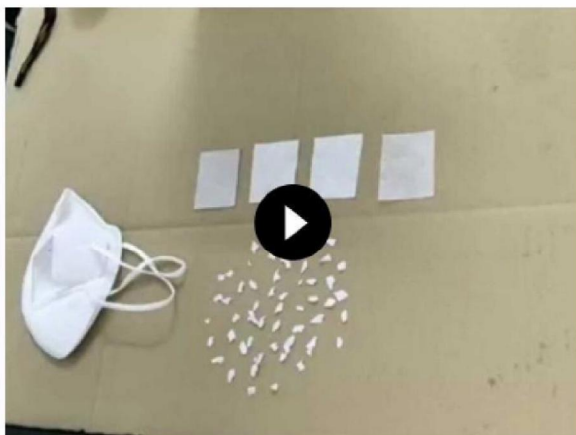
↑ 139 - Polarity Check

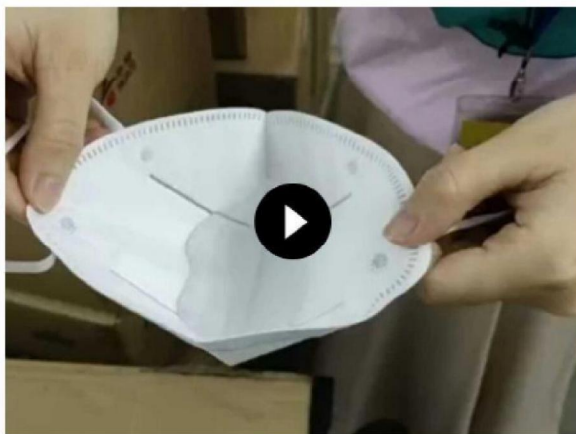
↑ 141 - Surface Wet Resistance Test

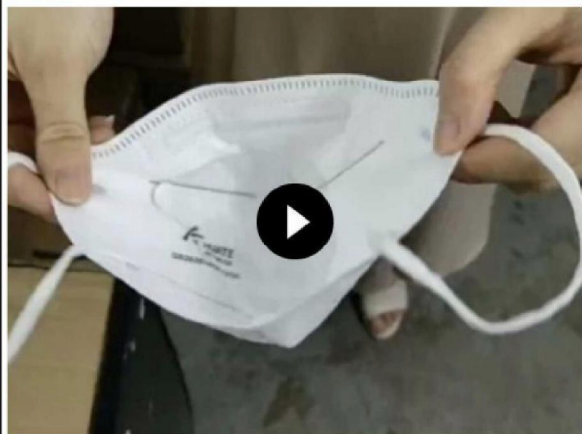
↑ 142 - Surface Wet Resistance Test
